# Building Inspection Report

## Sample Inspection Report Columbus, OH

Professional Property Inspection Consultants  
4857 Winterset Drive  
Columbus, OH 43220  
(614) 459-5941

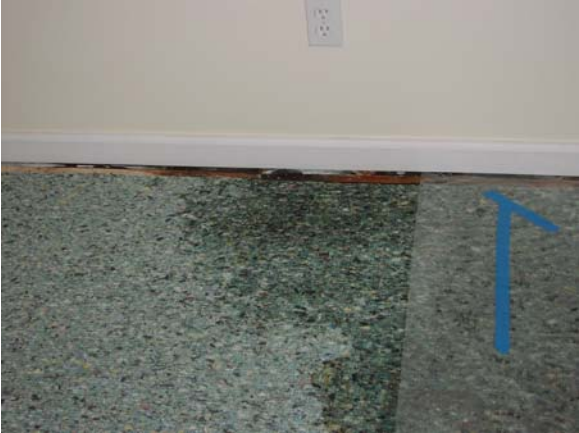
1. Signs of significant water infiltration were observed at the finished area of the basement. The carpet was pulled back and extensive wetness was observed along the south wall. Some dampness appears likely at other locations as well but may have dried. Stains were noted on the wall. It is the inspector's opinion that surface water control measures may be insufficient to ultimately guarantee a dry basement. It is recommended that a reputable qualified basement waterproofing contractor provide an estimate.

Signs of significant water infiltration were observed at the finished area of the basement. The carpet was pulled back and extensive wetness was observed along the south wall. Some dampness appears likely at other locations as well but may have dried. Stains were noted on the wall. It is the inspector's opinion that surface water control measures may be insufficient to ultimately guarantee a dry basement. It is recommended that a reputable qualified basement waterproofing contractor provide an estimate.

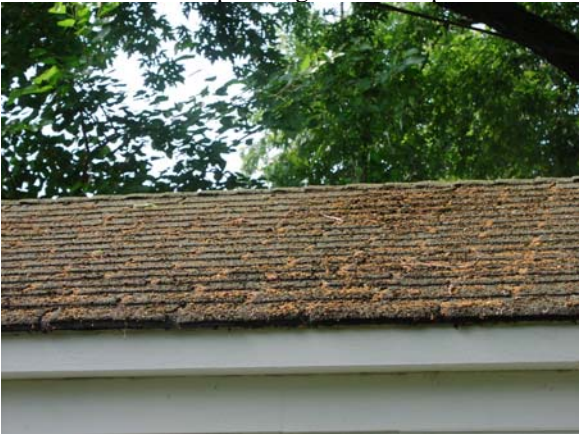
2. The garage roof needs to be replaced.
3. No power is present to the garage although an outlet and wiring was observed. The overhead service has been removed.
4. The basement floor drain was backing up when the utility sink was run. It is recommended that the drain be snaked to the sewer.
5. Leakage was noted at the shower in the basement. It appears to be coming from the shower door but it was not confirmed that no leak is present under the shower pan.

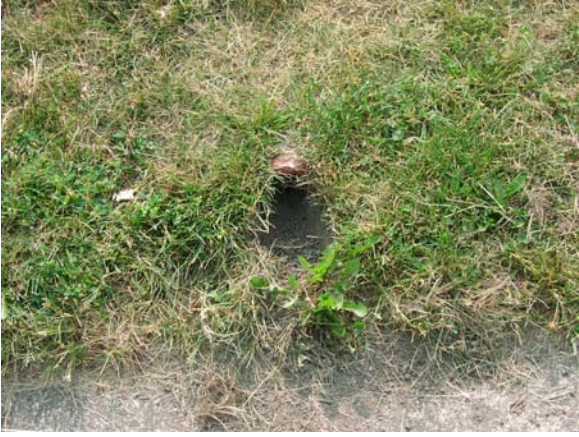
7. The main downspout line discharges over the sidewalk. This could be a city code issue and is a safety hazard.
8. Ungrounded 3 prong outlets were noted in the kitchen and the rear bedroom. One double tapped breaker was observed. The dryer outlet should be a double pole breaker.

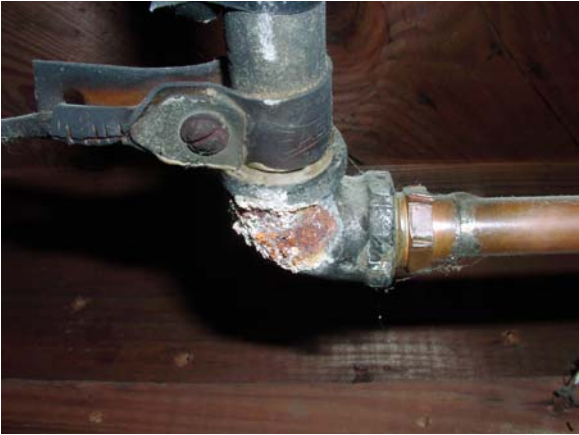
12. Some corrosion was noted between steel and copper piping. A dielectric connector is required to separate the metals.
13. Hand railings are recommended at stairs.
14. The rear door threshold is lacking support.
15. Smoke detectors should be installed. None are present.

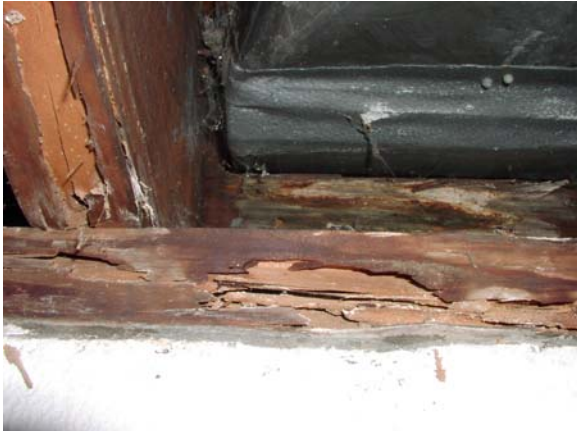
Some minor termite damage was observed at the northwest corner near the basement window. Repairs are considered discretionary.

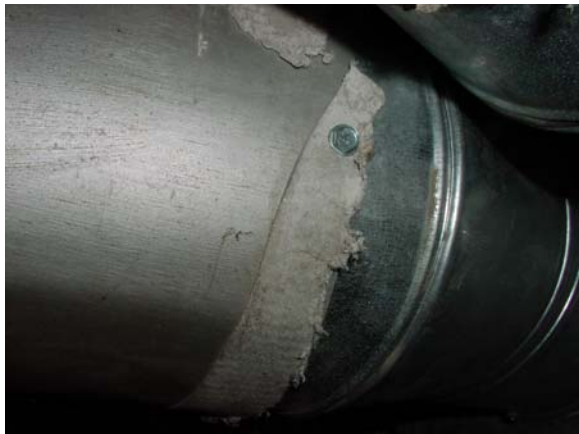
Some asbestos tape was observed as is typical for older homes of this era.

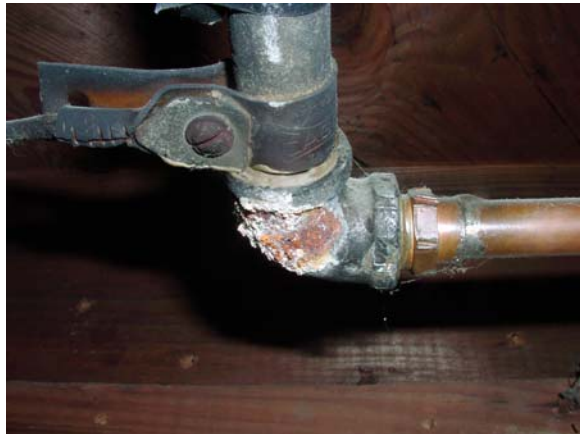
Some corrosion was noted between steel and copper piping. A dielectric connector is required to separate the metals.

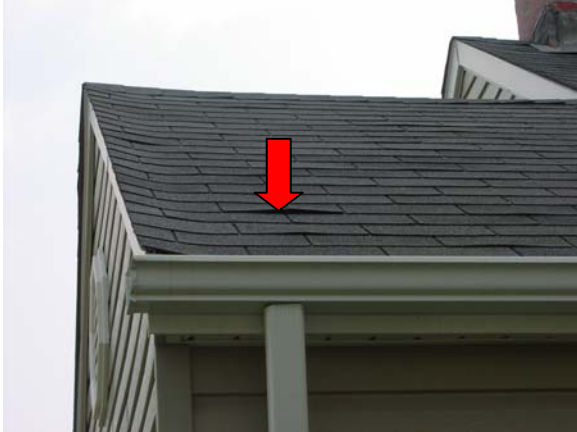
Some nail pops were observed due to improper nailing.  
The garage roof needs to be replaced.

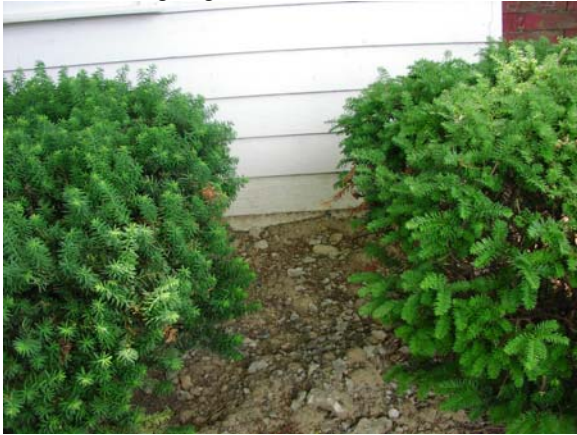
The overhead garage door has a broken rail.

Dirt to wood contact should be eliminated to avoid rot and insect damage. Most of the structure was concealed by drywall.
